# Manhole Inspection Summary

Manhole # S33EE\_004MH

Insp Date: **2/27/07 1:10 PM**

**Location** Address: **1020 PARK AVE**

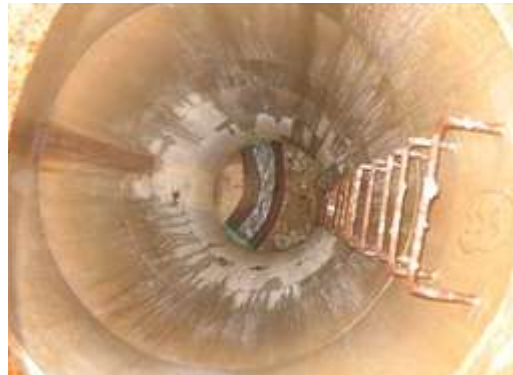
Top View

Corroded steps. Bench debris.

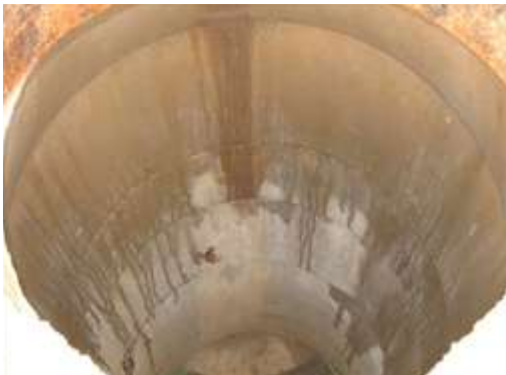
Defect

**Frame** Offset: **7** (in.) Condition: ☒ Sound ☐ Cracked ☒ **Leaks**

**Chimney / Frame Adjustment** ☒ Exists Material: **Brick** ☐ Parged Height: **7** (in.)  
Condition: ☒ Sound ☐ Cracked ☐ Root Intrusion ☐ Loose Brick ☐ Deteriorated  
Infiltration: ☐ None ☒ **Joint** ☐ Cracks ☒ **Mortar** ☐ Roots ☐ Wall

Frame offset. Adjustment infiltration.

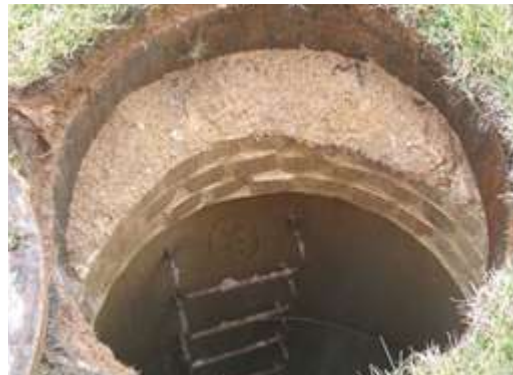
Defect

Frame offset. Adjustment infiltration.

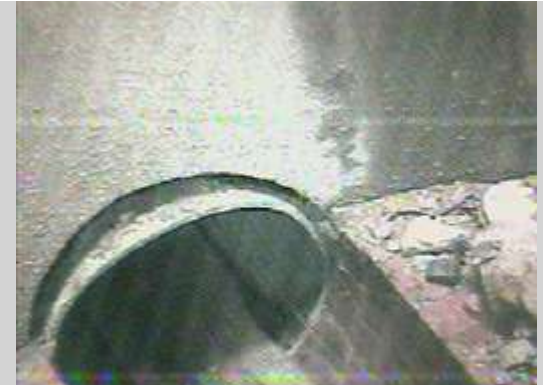
### 8 in. Circular Gravity Sewer Pipe Out @ 12 O'Clock

Comments **The O12 pipe seal is not flush to the pipe.**

Infiltration: **None** Pipe Seal Cond: **Unknown**

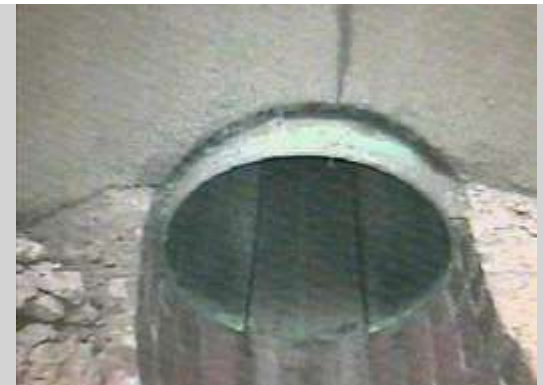
### 8 in. Circular Gravity Sewer Pipe In @ 7 O'Clock

Infiltration: **Evidence** Pipe Seal Cond: **Unknown**
